# THE MIAMI CONSERVANCY BULLETIN

DECEMBER 1919

## **Index**

Page		Page
Editorials .....	67	Railway Grading With Stiff-leg Derrick Draglines .....	75
Building the Hamilton Storm Sewers.....	69	65,000 Cubic Yards Moved for 26.7 Cents Per Yard.	
Three Concrete Sewers, 4' to 5' 8" in Size, and Totalling 4160' in Length, Have Been Built.		Flood Protection Work at Middletown.....	77
Hydraulic Fill at Germantown.....	72	Influenza and Conservancy Medical Service.....	79
November Progress on the Work.....	73

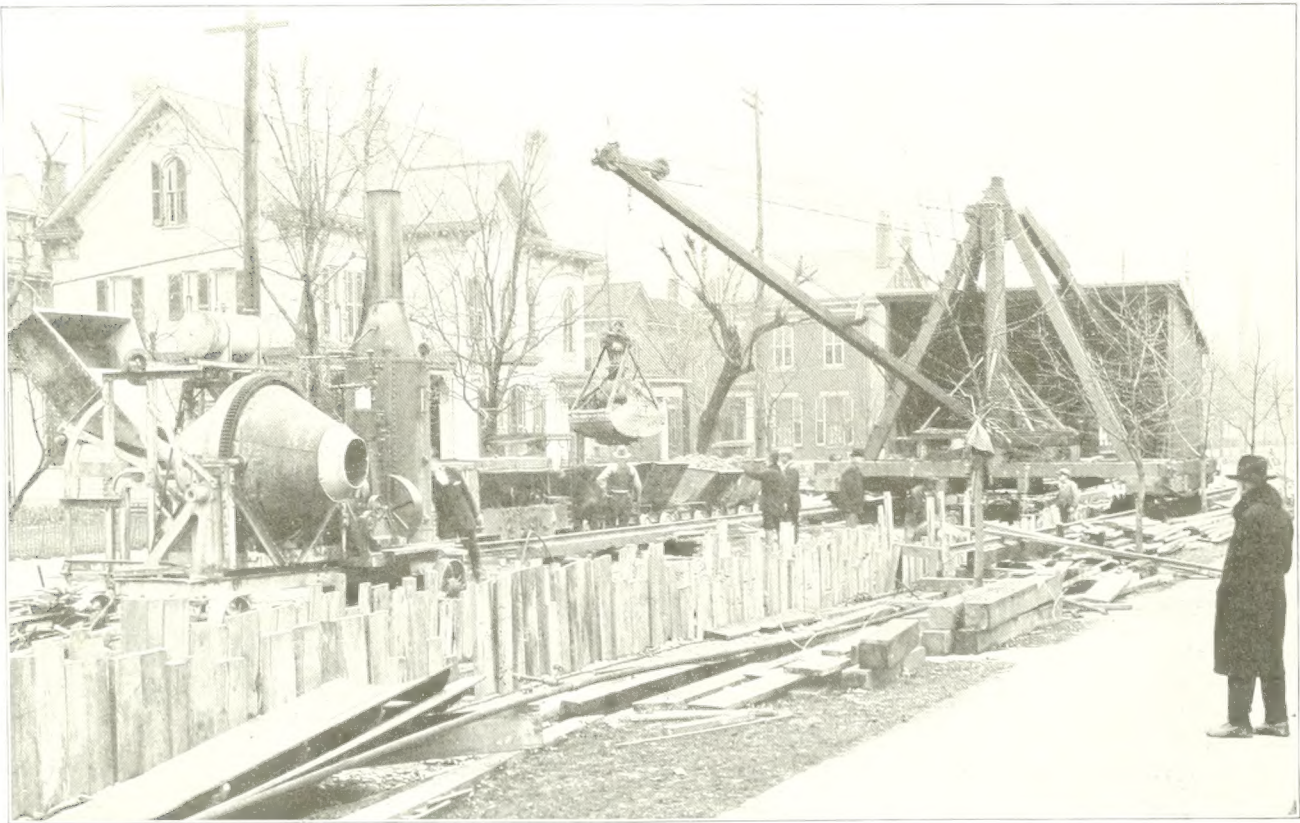
FIG. 56—SEWER EQUIPMENT ON BUCKEYE STREET, HAMILTON

A view of the equipment used in building the Hamilton storm sewers, consisting of a  $\frac{1}{2}$ -yard Smith concrete mixer, portable electric derrick with  $\frac{3}{4}$ -yard clamshell bucket, a 3-ton Plymouth gasoline locomotive and four  $1\frac{1}{2}$ -yard side dump cars. This picture was taken on Buckeye Street near Third. Taken Nov. 20, 1919.

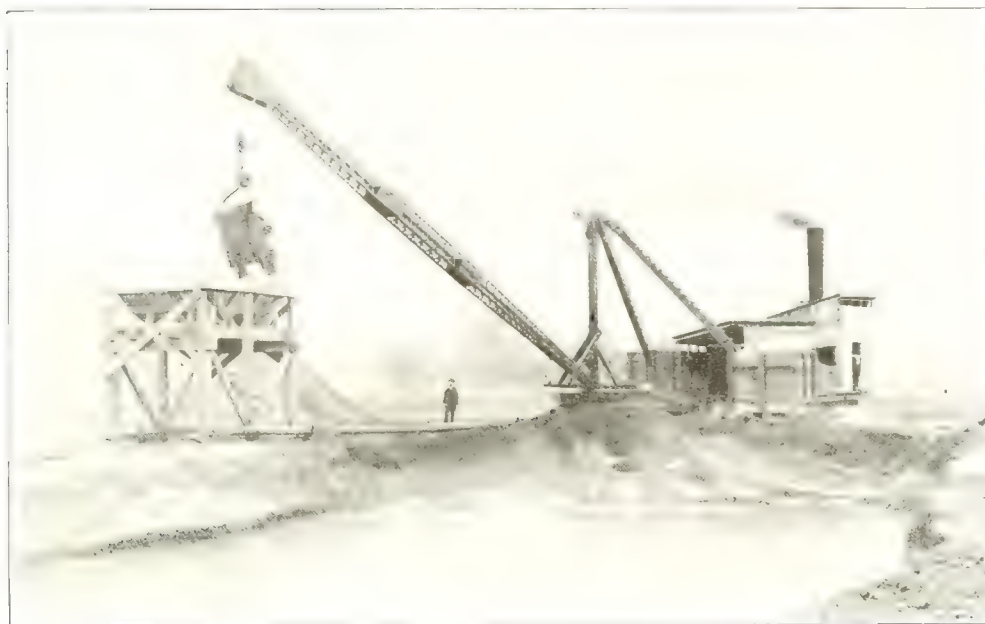
FIG. 64—DERRICK DRAGLINES LOADING CONCRETE GRAVEL, MAY 5, 1919

A stiffleg derrick converted into a dragline excavator. It is excavating gravel from the Ohio Electric R. R. borrow pit into the hopper, whence it drops into dump wagons, to be taken to the mixer at Smith Ditch concrete trestle. The steel boom was made from one of the stifflegs taken from a converted derrick on the Conservancy work at Lockington. Taken May 5, 1919.

The two derricks, thus equipped, are shown at work in Fig. 65. One of them, temporarily in use to load gravel for concrete bridge work, is shown in Fig. 64. The derricks ran on timber ways built up about 18" from the ground. This arrangement fitted well with the work of clearing out stumps, several acres of which had to be hauled. The trees were sawed off close enough to the ground to permit the draglines to run over them, thus bringing them into the borrow pit, whence they were pulled by the dragline buckets acting as "tooth extractors."

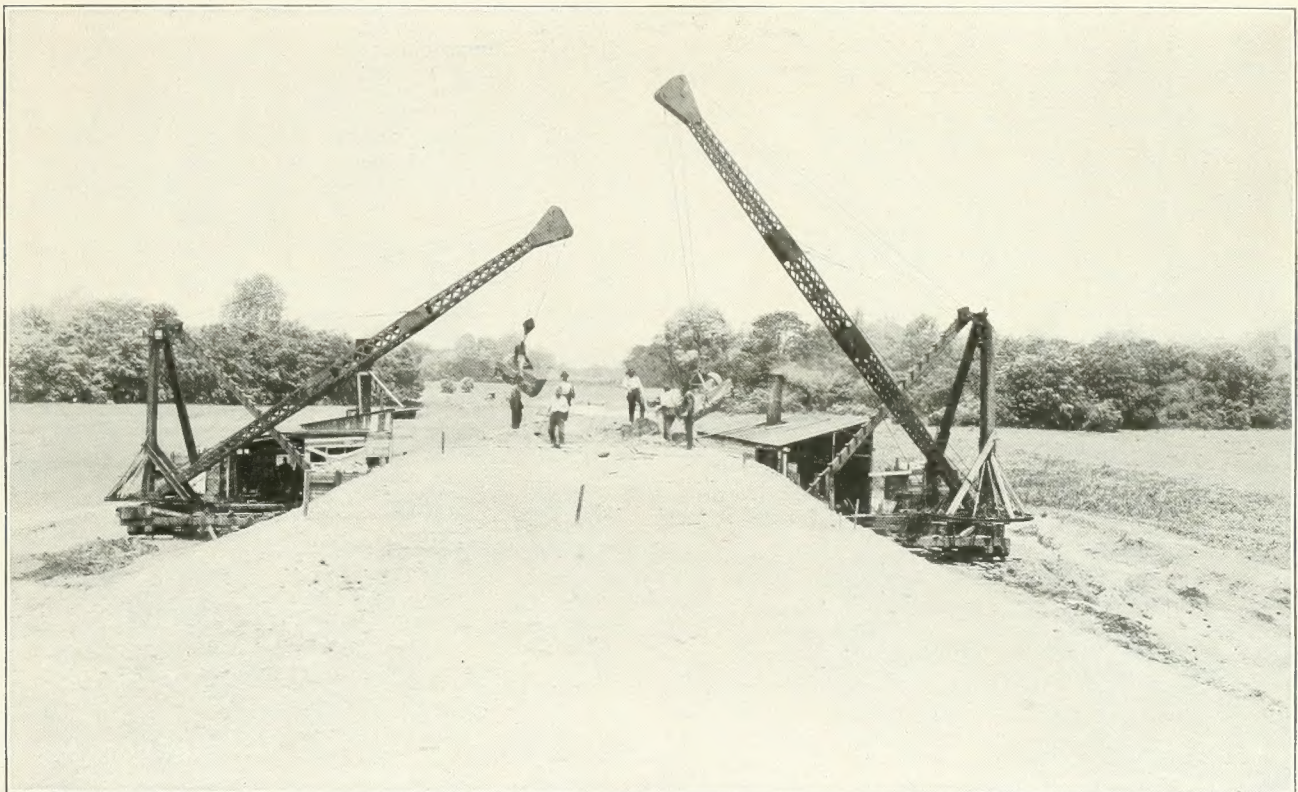
FIG. 65—TEAM OF DERRICK DRAGLINES BUILDING OHIO ELECTRIC RAILWAY EMBANKMENT

The embankment,  $1\frac{1}{2}$  miles long, extending across the flats of the Mad River Valley, and totalling 65,000 cubic yards, was built by these machines at a cost of 26.7 cents per yard, including cost of converting the booms and making the experimental transformations. The derricks "crawfished" down the pike on wood rollers running on a timber crib built high enough to permit running over the stumps (sawed low), which were then snagged out of the pit by the drag bucket. The depreciation in these drags was negative, as they finished the job in much better shape than when they began. Cables, sheaves and goose necks proved to be the weak spots in the original mechanism, as applied to such work as this. Mad River (beyond the trees in the distance) was crossed on the timber falsework for the new concrete bridge. The crossing took two days. Most of the material for the railway embankment was taken from under water, making an exceptionally solid bank. Shrinkage about  $2\frac{1}{2}$  per cent.

The District had two stiff-leg derricks available which had been in use at Ohborn, both as derricks and as clam shells with 1-yard buckets. It was proposed to take these two derricks, equip them with 1½-yard dragline buckets, and work them as a team side by side, one to a borrow pit, on each side of the embankment to be built. (See Fig. 65.)
